DELTA Test Report

IP65 Tightness test of G-Spot Moving Head Profile

Performed for SGM A/S

DANAK-19/14122

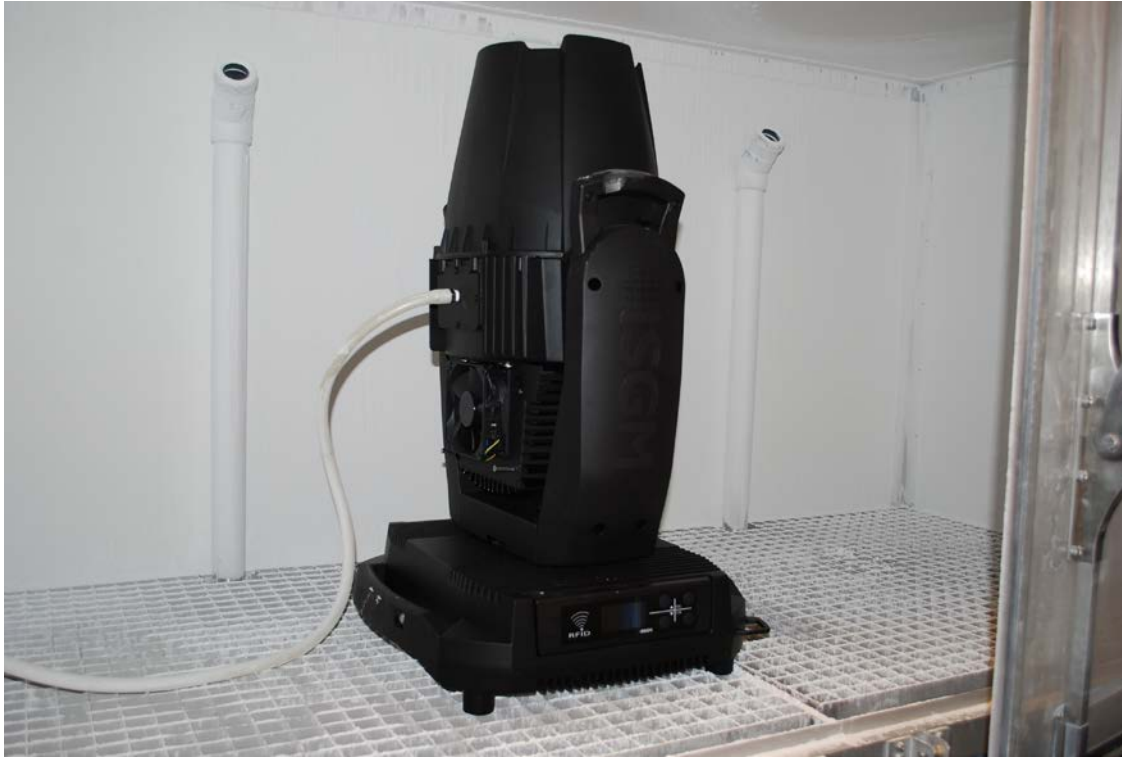
Photo 1. IP6X Test G-Spot Moving Head Profile before exposure.

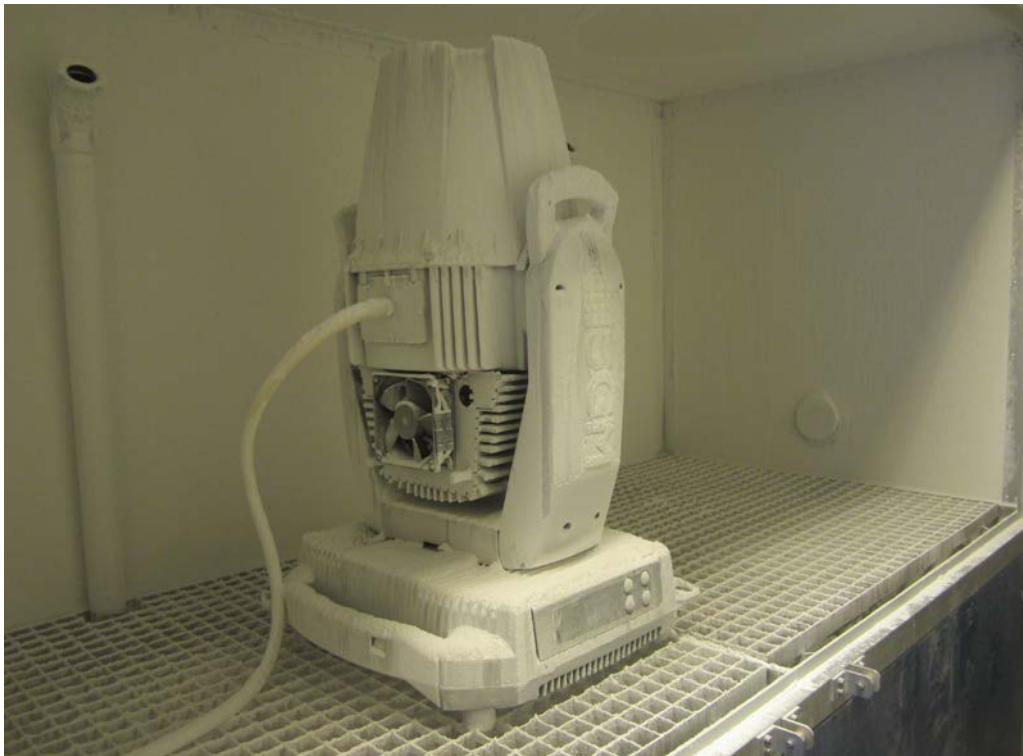
Photo 2. IP6X The G-Spot Moving Head Profile after exposure.

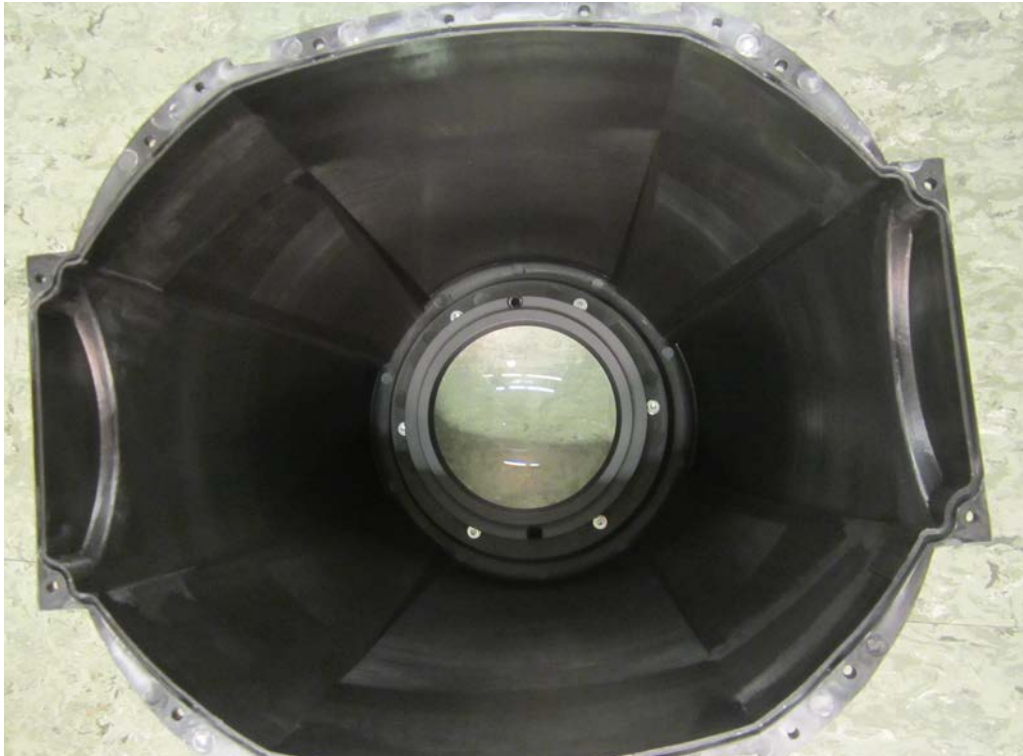
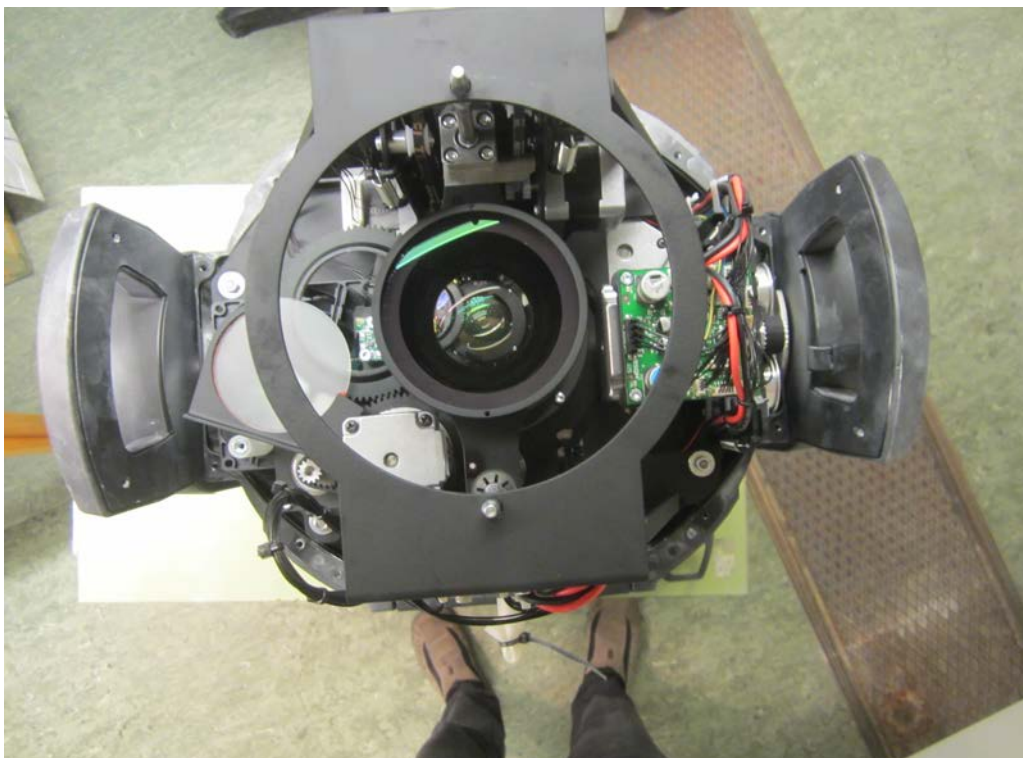
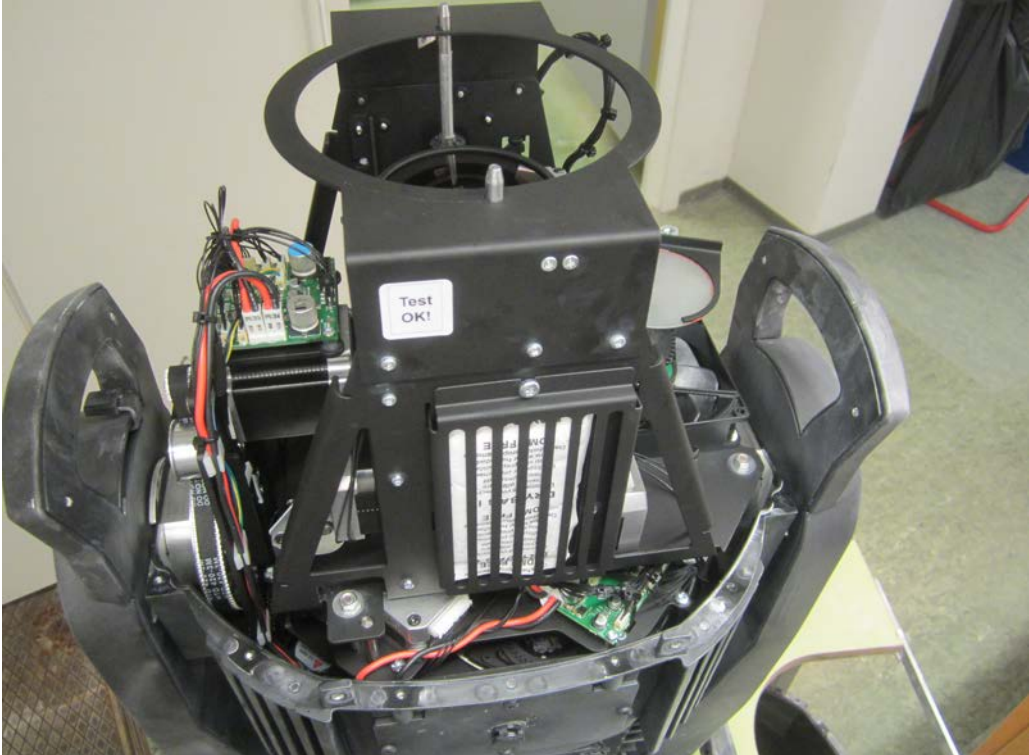
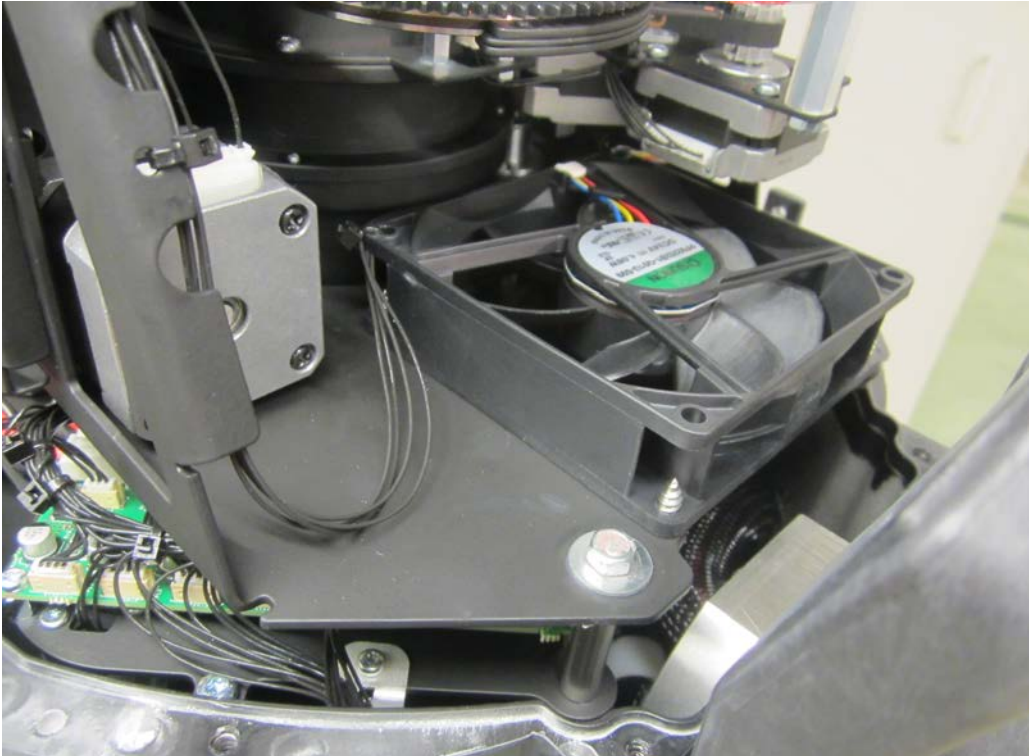
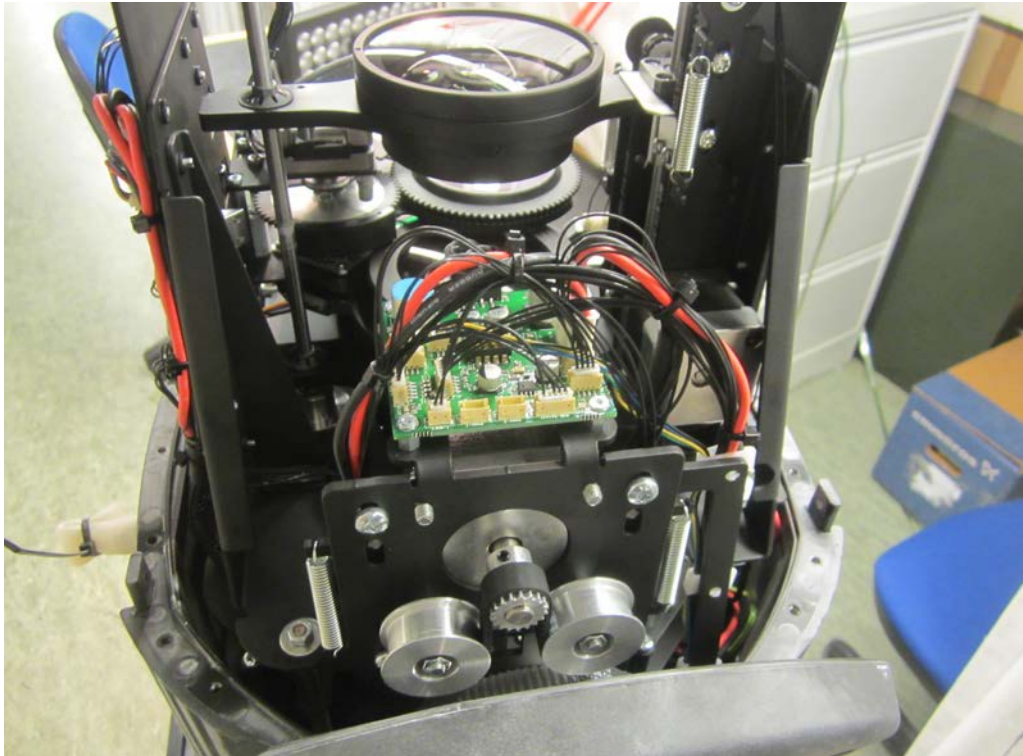
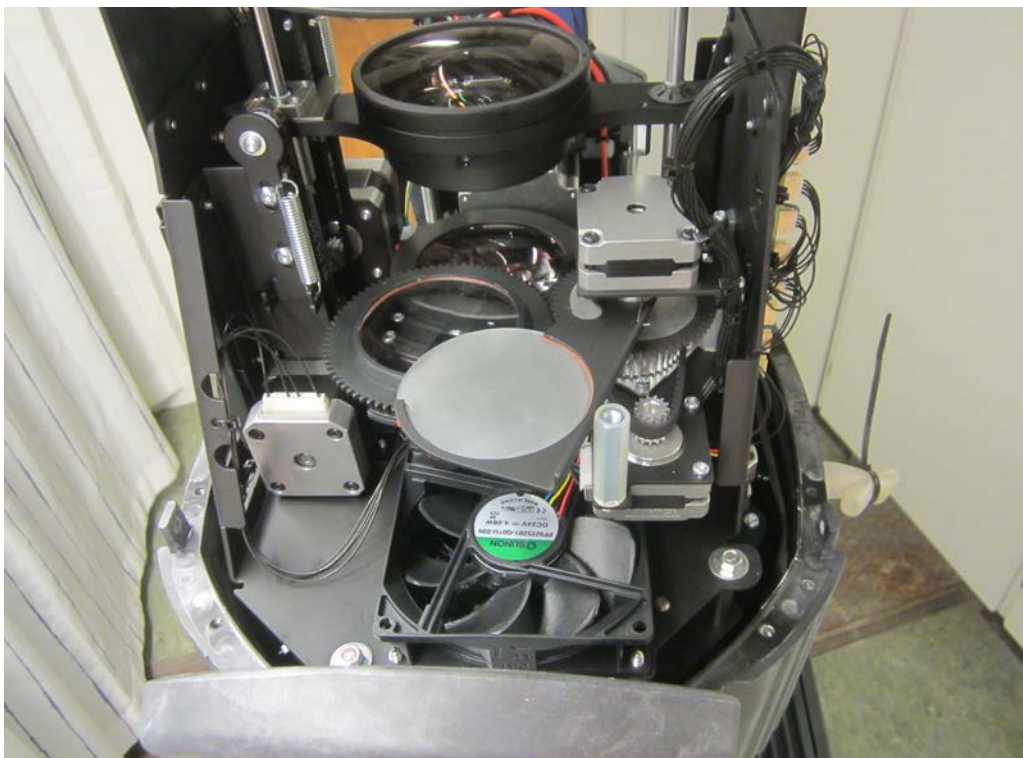
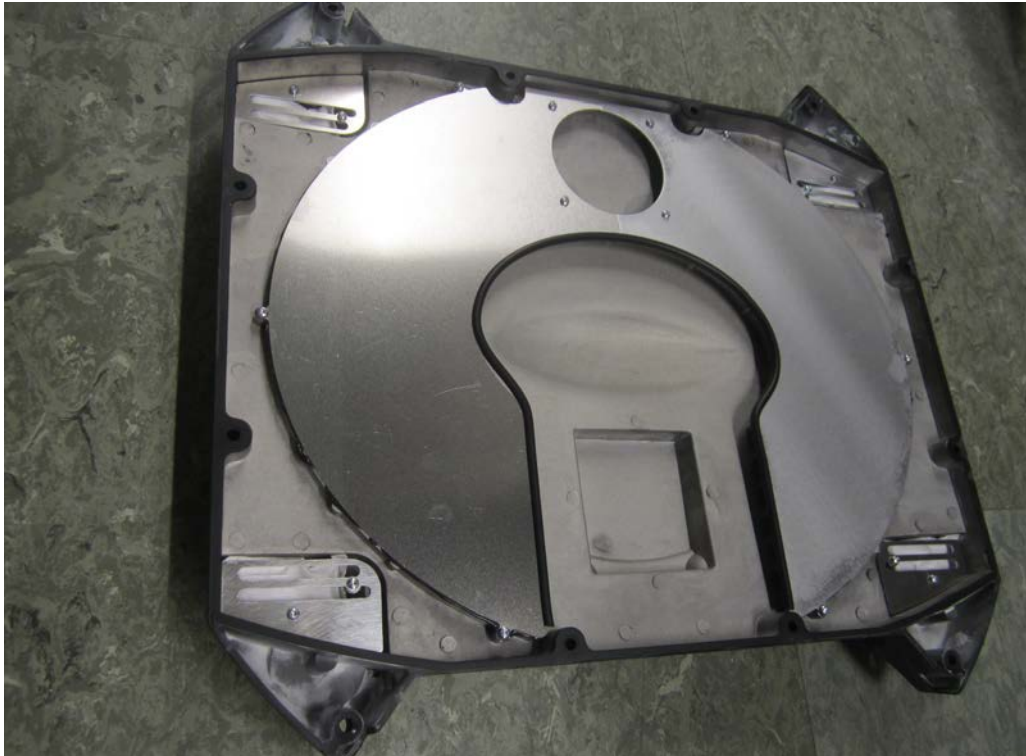
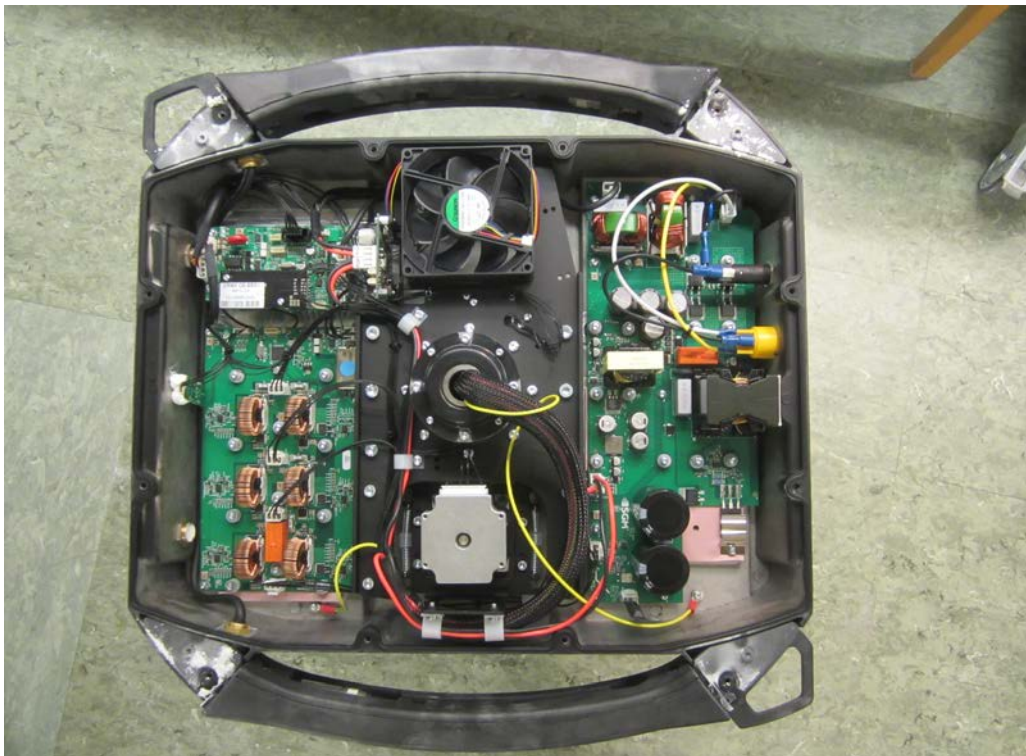
No dust was observed inside the G-Spot Moving Head Profile during the visual inspection performed after the IP6X exposure. Thus the degree of protection against dust corresponds to IP6X (as described in IEC 60529 Edition 2.1, IP6X) for the G-Spot Moving Head Profile.

Photo 3. IP6X No dust observed inside G-Spot Moving Head Profile.

Photo 4. IP6X No dust observed inside the G-Spot Moving Head Profile.

Photo 5. IP6X No dust observed inside the G-Spot Moving Head Profile.

Photo 6. IP6X No dust observed inside the G-Spot Moving Head Profile.

Photo 7. IP6X No dust observed inside the G-Spot Moving Head Profile.

Photo 8. IP6X No dust observed inside the G-Spot Moving Head Profile.

Photo 9. IP6X No dust observed inside the G-Spot Moving Head Profile.

Photo 10. IP6X No dust observed inside the G-Spot Moving Head Profile.

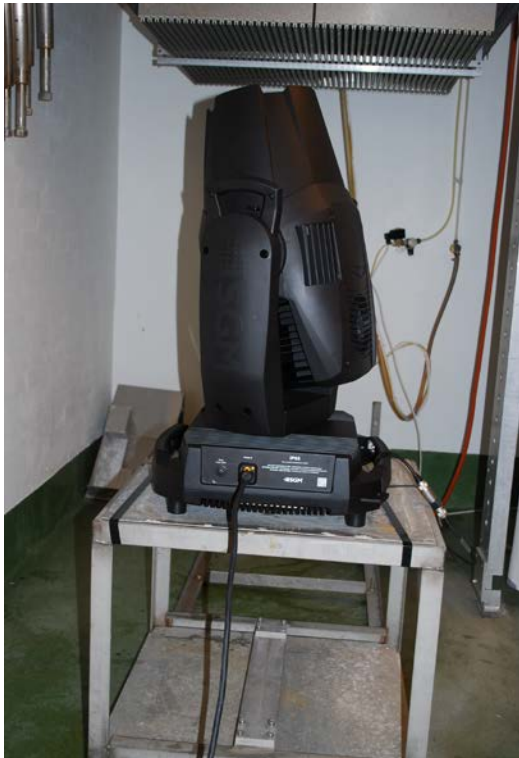
Photo 11. IPX5 Before exposure.

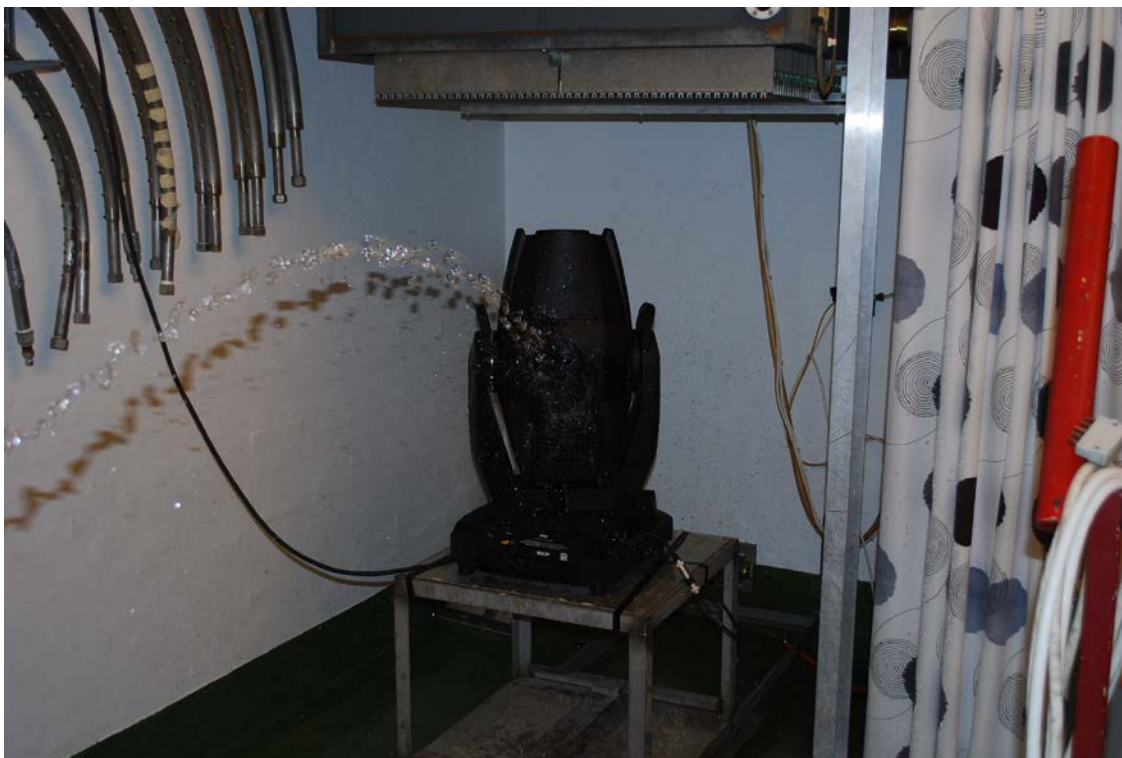
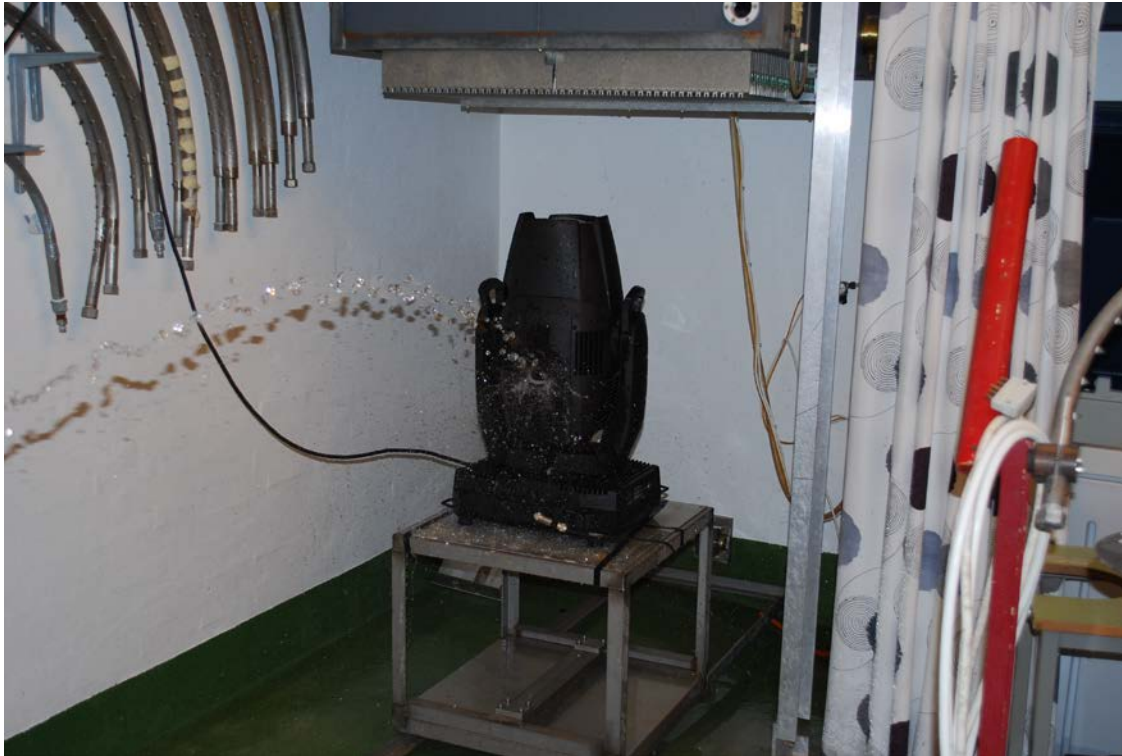
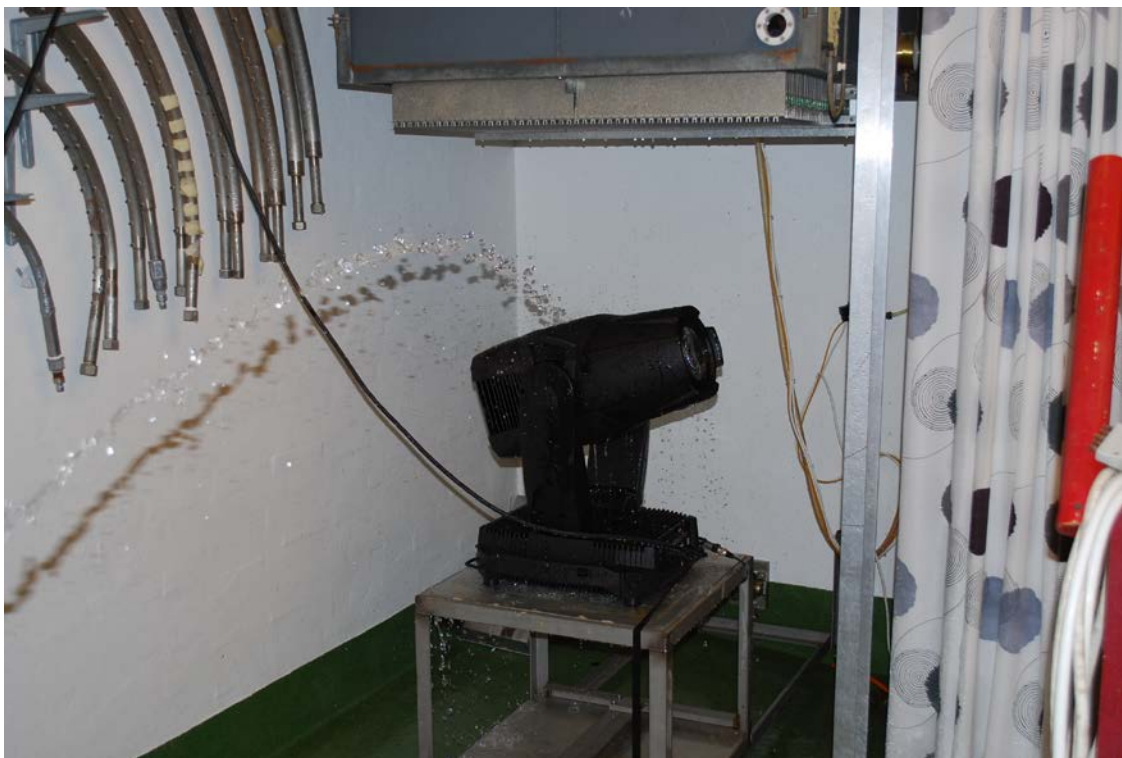
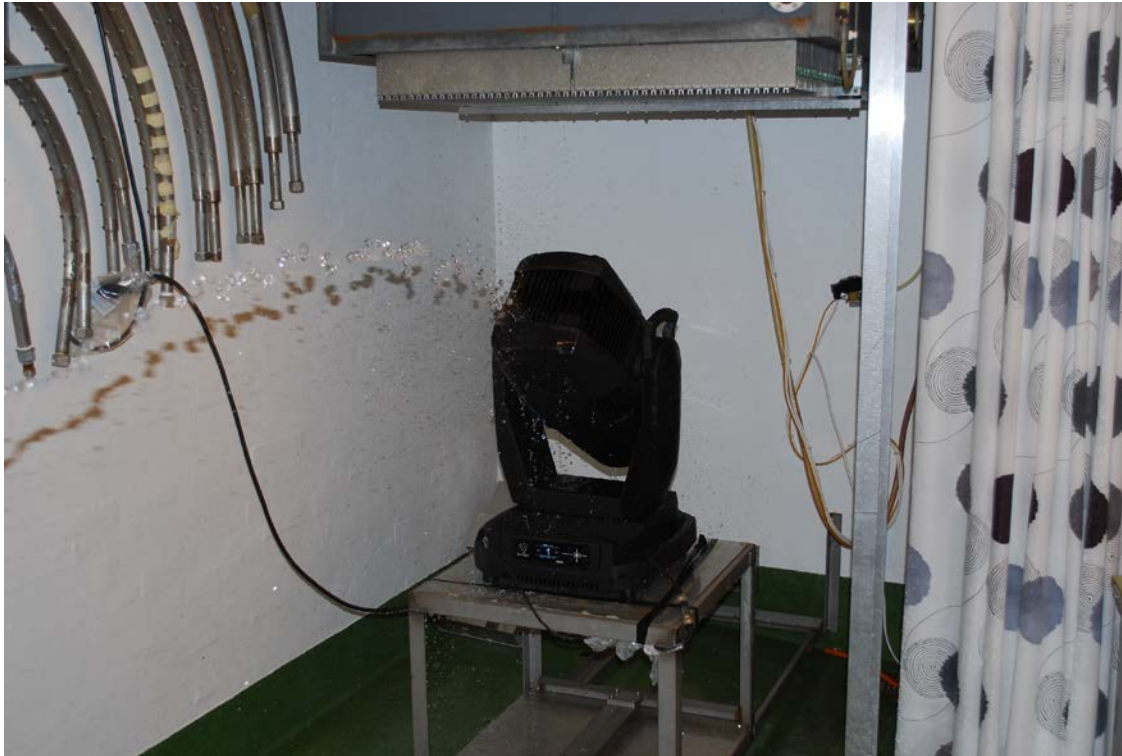
Photo 12. IPX5 During exposure.

Photo 13. IPX5 During exposure.

Photo 14. IPX5 During exposure.

Photo 15. IPX5 During exposure.

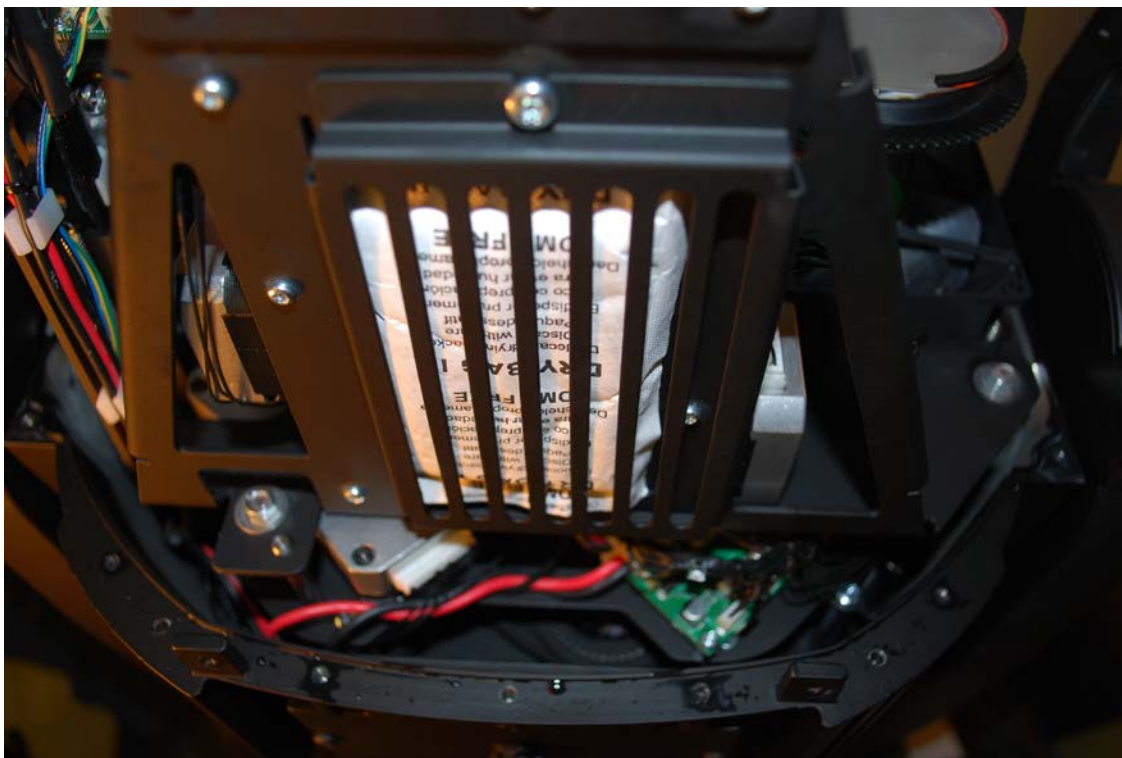
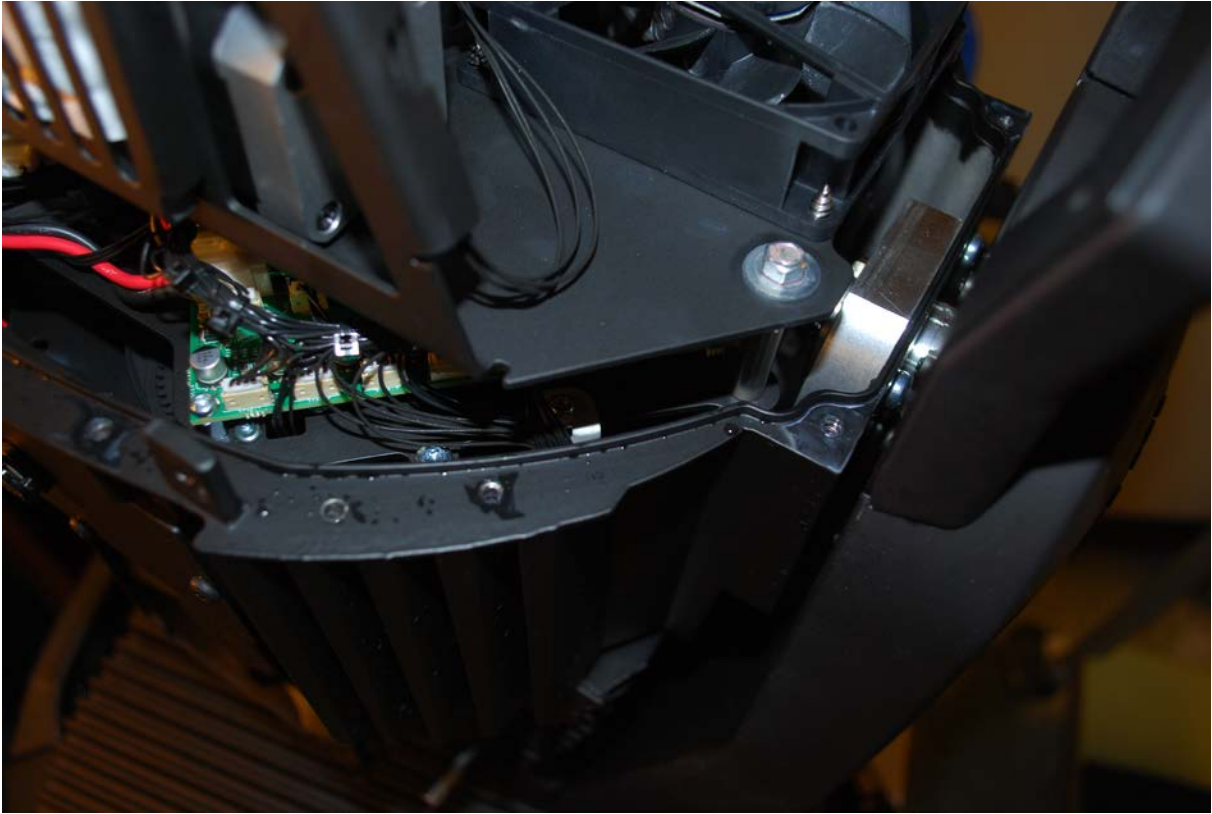
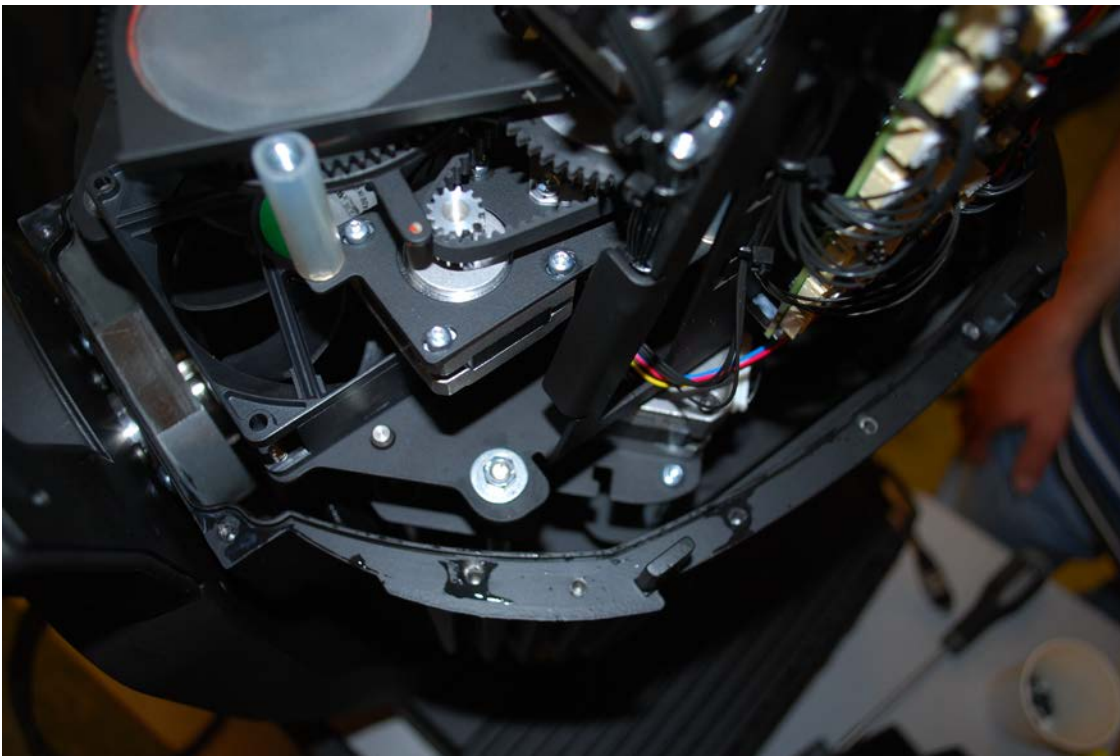
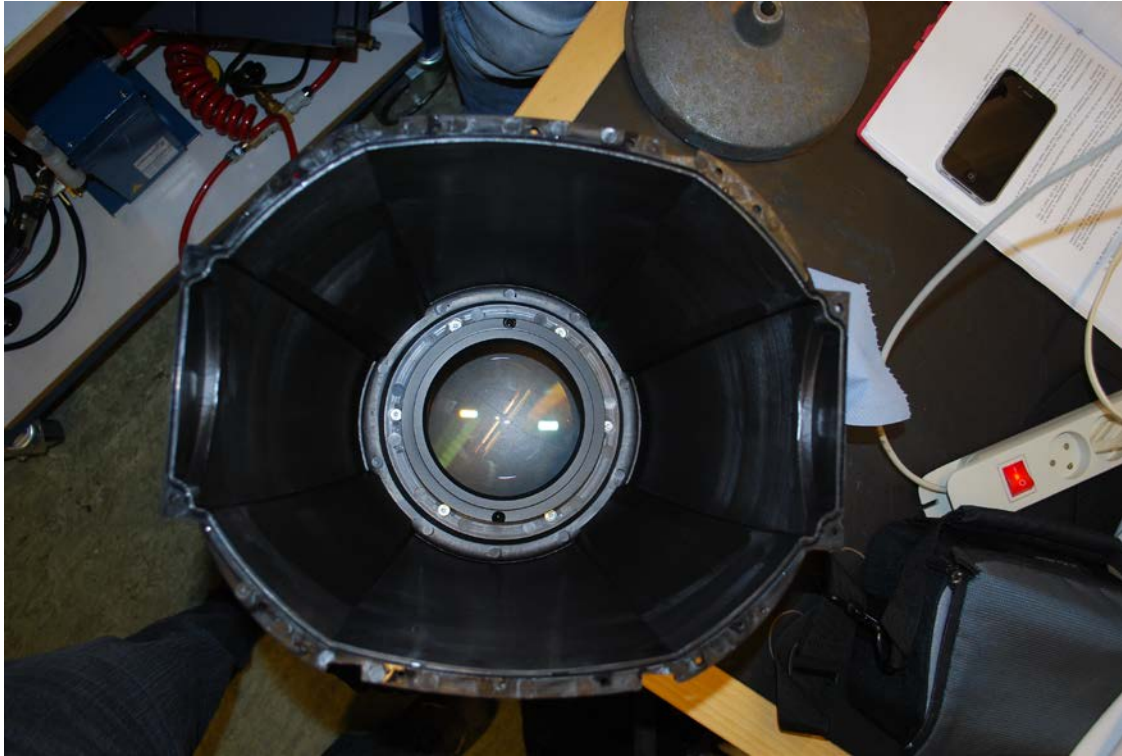
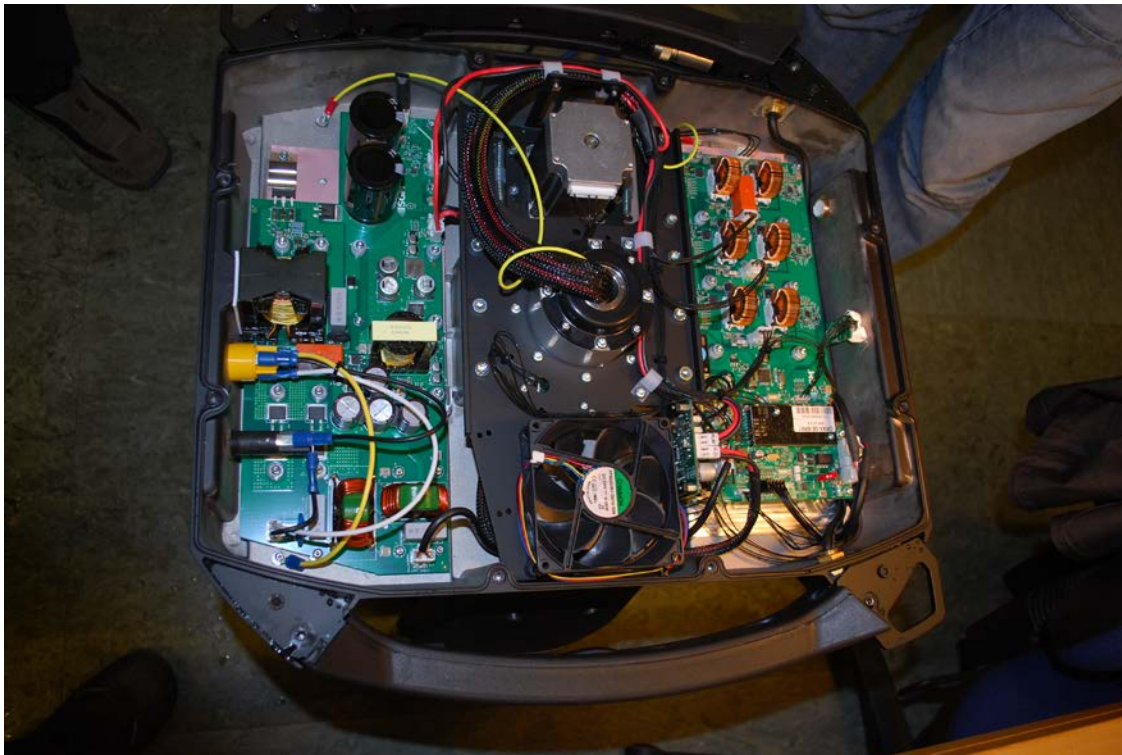
No water was observed inside the G-Spot Moving Head Profile during the visual inspection performed after the IPX5 exposure. Thus the degree of protection against water corresponds to IPX5 (as described in IEC 60529 Edition 2.1, IPX5) for the G-Spot Moving Head Profile.

Photo 16. IPX5 No water observed inside the G-Spot Moving Head Profile.

Photo 17. IPX5 No water observed inside the G-Spot Moving Head Profile.

Photo 18. IPX5 No water observed inside the G-Spot Moving Head Profile.

Photo 19. IPX5 No water observed inside the G-Spot Moving Head Profile.

Photo 20. IPX5 No water observed inside the G-Spot Moving Head Profile.
